DEPARTMENT OF TRANSPORTATION

Quality Assurance and Source Inspection

Contract #: 04-0120F4Cty: SF/ALA Rte: 80 PM: 13.2/13.9File #: 69.28**WELDING INSPECTION REPORT****Resident Engineer:**Pursell, Gary**Address:** 333 Burma Road**City:** Oakland, CA 94607**Report No:** WIR-016493**Date Inspected:** 11-Aug-2010**Project Name:** SAS Superstructure**OSM Arrival Time:** 700**Prime Contractor:** American Bridge/Fluor Enterprises, a JV**OSM Departure Time:** 1900**Contractor:** Zhenhua Port Machinery Company, Ltd (ZPMC), Changxing Island **Location:** Shanghai, China

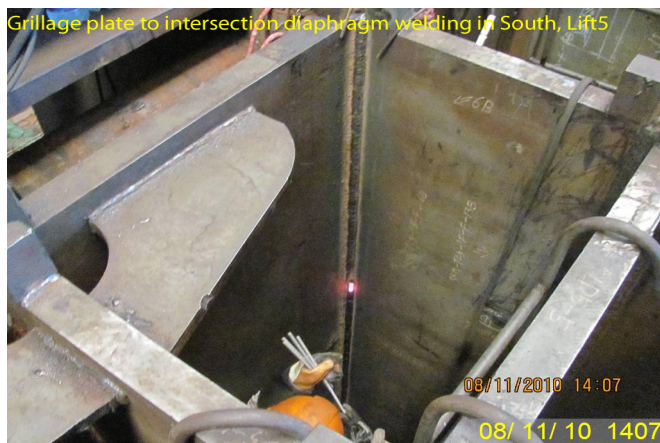
1. This QA inspector, Baskar Govindarajan, observed, ZPMC qualified welding personnel identified as 057258 perform SMAW welding on; South shaft, Lift 5, intersection diaphragm plate to Skin E (outside)and the weld joint is identified as SSD1-TL5-1 B/F-53. ZPMC CWI Identified as Mr. Qiu Wen. The welding parameters as measured using QC's calibrated instruments appeared to be in general compliance with WPS-B-T-3213-TC-U4C. (Photo attached)

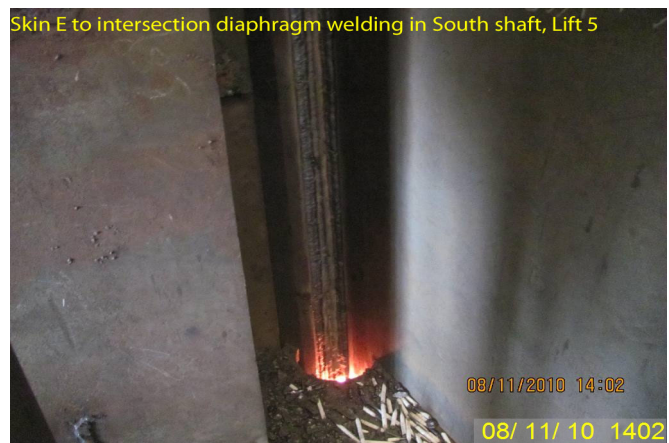
2. This QA inspector, Baskar Govindarajan, observed, ZPMC qualified welding personnel identified as 057266 perform SMAW welding on; South shaft, Lift 5, intersection diaphragm plate to Skin A and the weld joint is identified as SSD1-TL5-1 B/F-6B. ZPMC CWI Identified as Mr. Qiu Wen. The welding parameters as measured using QC's calibrated instruments appeared to be in general compliance with WPS-B-T-3213-TC-U5B. (Photo attached)
